**EAGLE LAKE DAM**

**MA 00979**

**PHASE I INSPECTION REPORT  
NATIONAL DAM INSPECTION PROGRAM**

**AUGUST 1978**

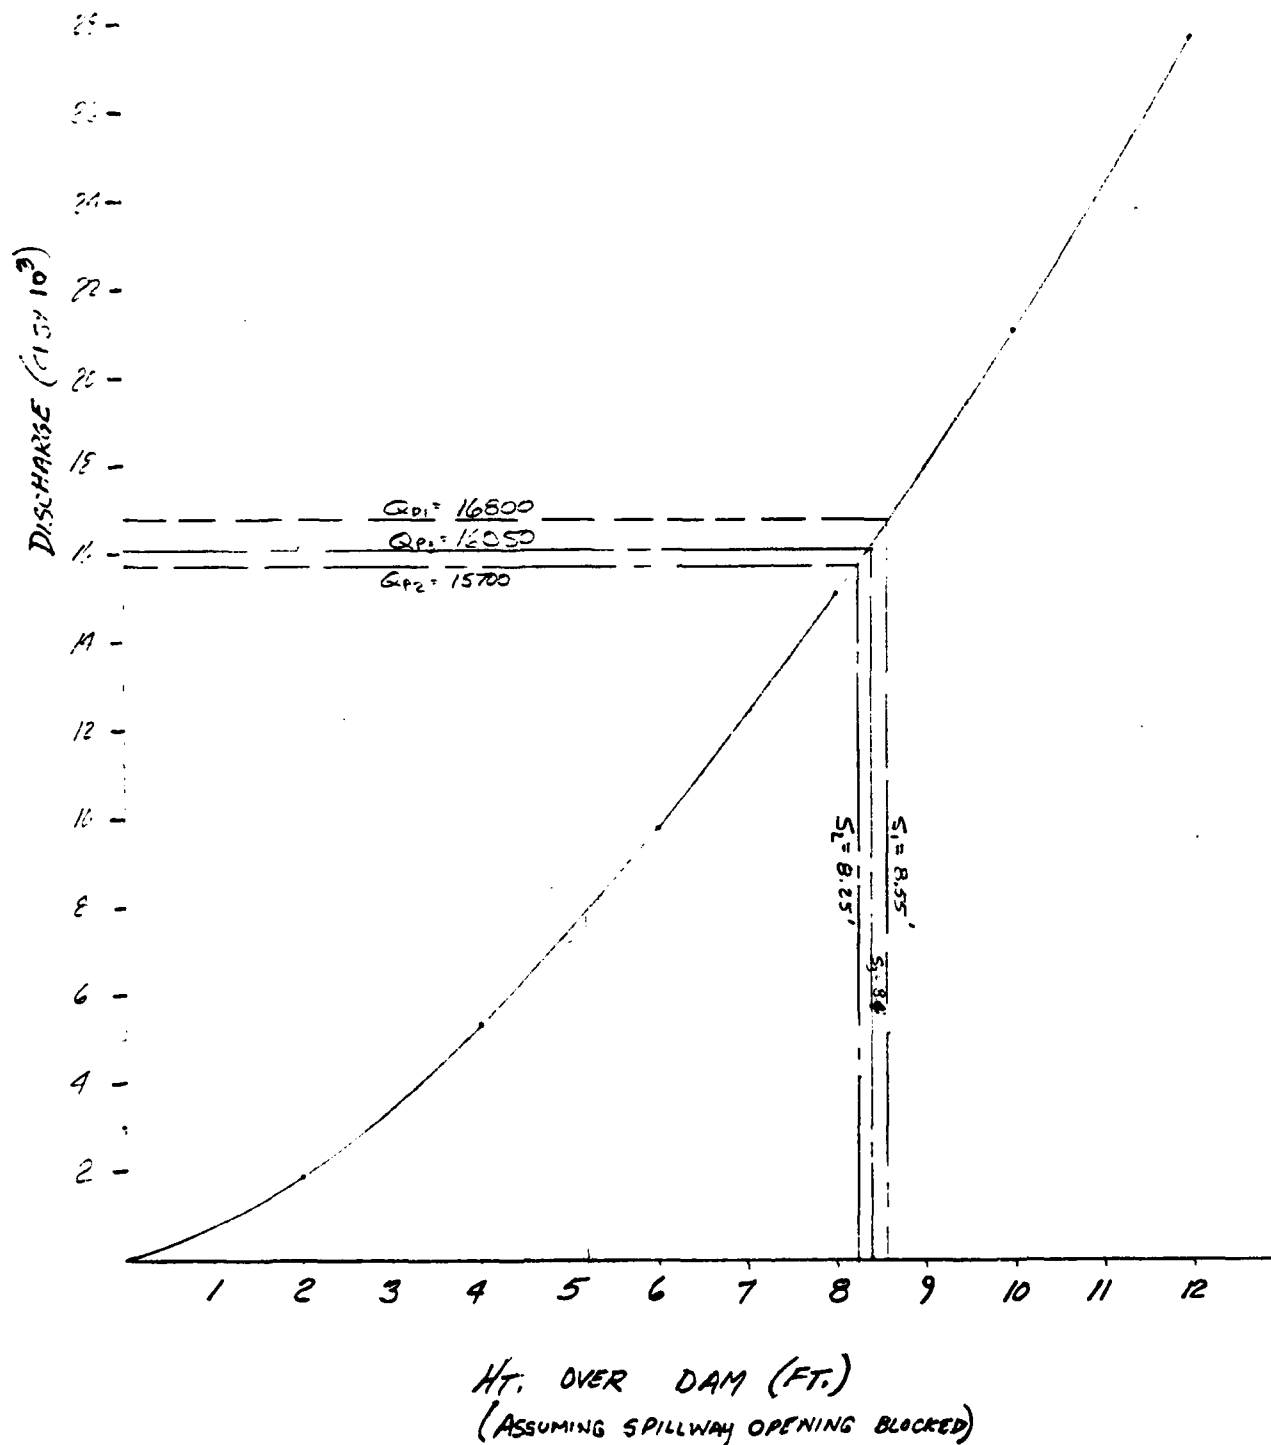
HT. OVER DAM (FT.)  
(ASSUMING SPILLWAY OPENING BLOCKED)

ASSUME SARLWAY OPENING CLOGGED BY DEBRIS.

WATER FLOW OVER BRIDGE DECK & DAM. (smooth & Level.)
